# Precast Design Flaws: A Case Study on Coordination Issues in Saudi Arabia Residential Villa Project

Publication Date: April 26, 2025

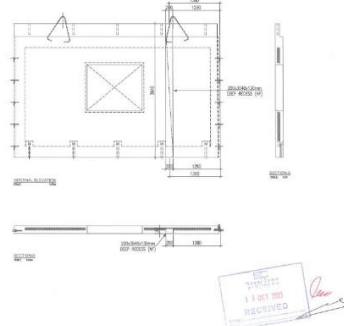
| 14 | PMZ-SW21-1F-007 | <p>PMZ-SW21-1F-007</p> <p>Missing MEP box in NF</p> | <p>As per the approved MEP drawing, there's no MEP box in the NF. Please refer to NCR-DE-23-0457.</p> <p>Status: Sent for rectification Date: 11/19/2023</p> |
